BABBIDGE RESERVOIR DAM

NH 00398  
NHWRB 206.03

PHASE I INSPECTION REPORT  
NATIONAL DAM INSPECTION PROGRAM

AUGUST 1981

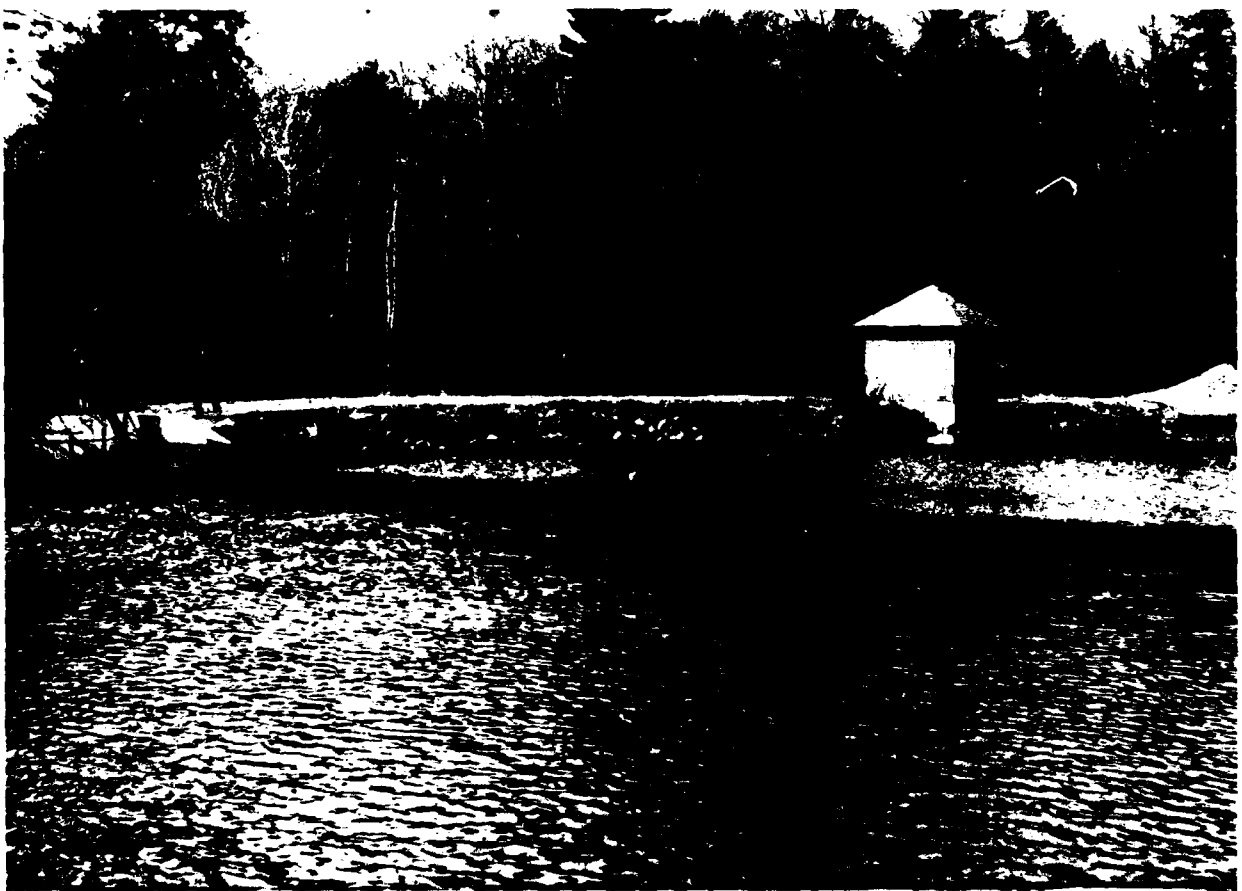
Overview of Dam

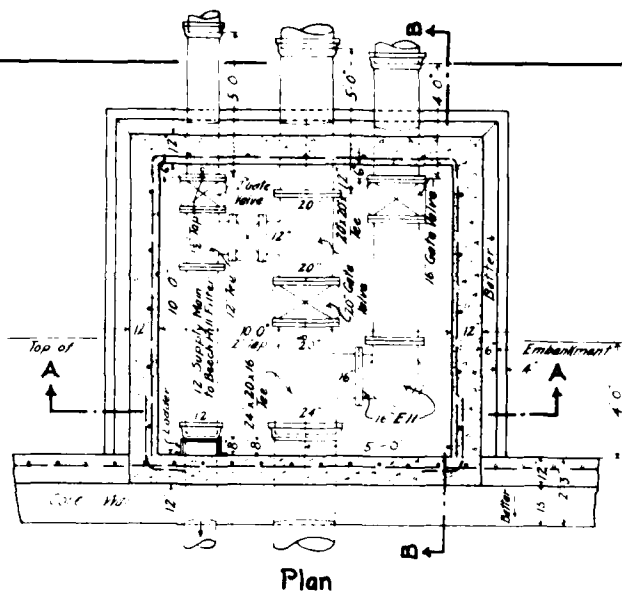
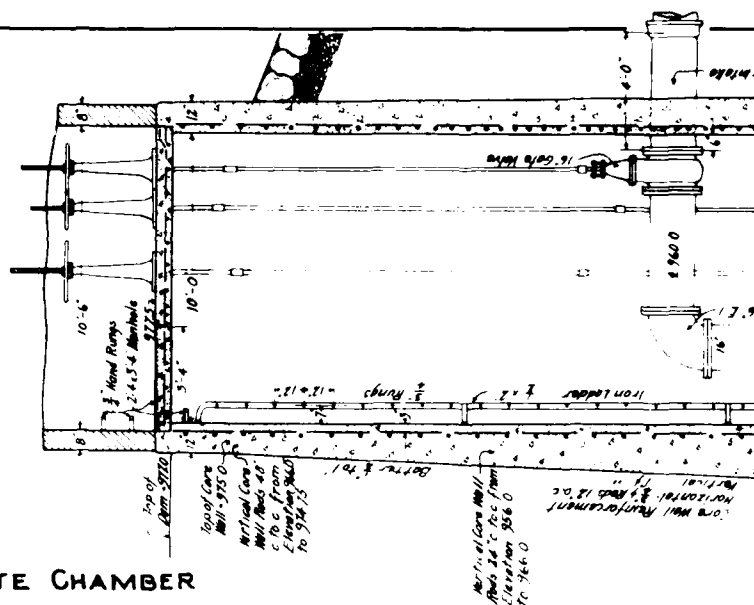
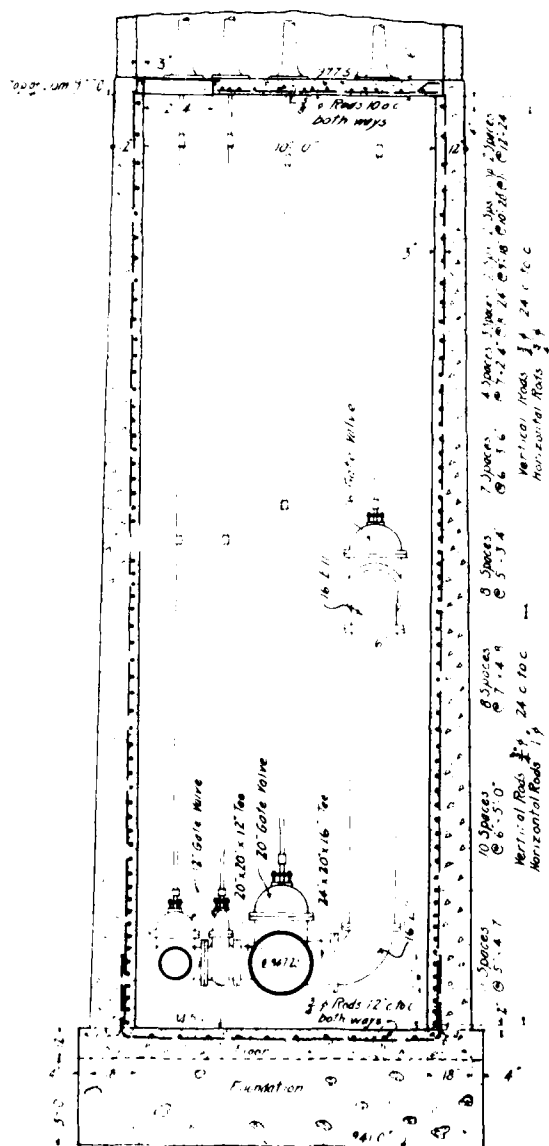
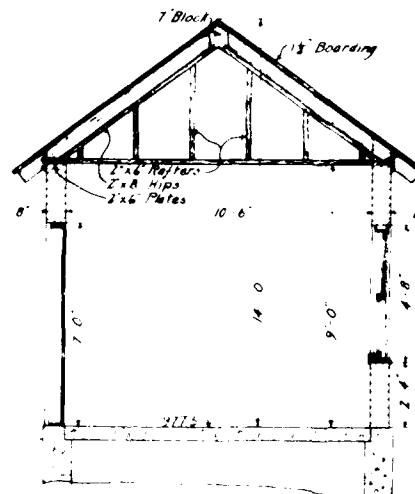
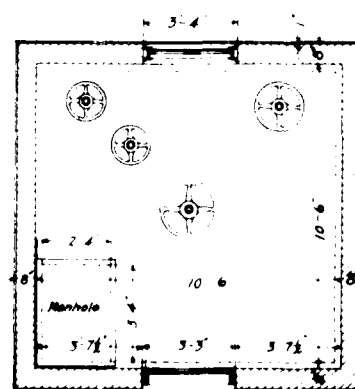
Plan  
GATE HOUSE

CHECKLIST FOR VISUAL INSPECTION		
AREA EVALUATED	BY	CONDITIONS AND REMARKS
<u>GATEHOUSE</u>		
Foundation	PR	Erosion 12 inches high, 12 inches wide, and 6 inches deep at left upstream corner
Bearing Walls		Good
Wood Framed Roof	PR	Good
<u>RESERVOIR AREA</u>		
Slopes	NAL	Generally shallow to moderate slope. Appear to be stable and in good condition

(e) Repair the concrete on the gatehouse, right end wall, and spillway.

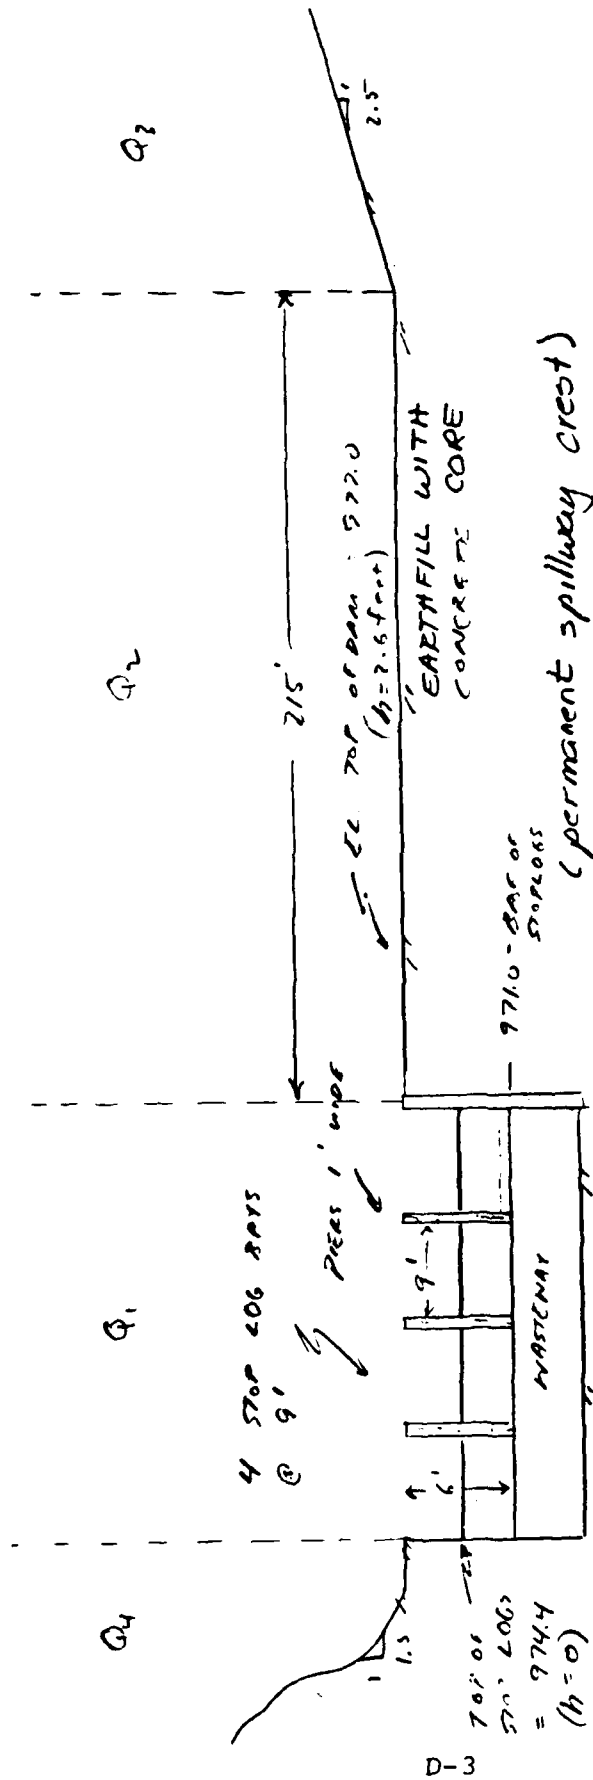
BABBIDGE DAM  
(Looking Downstream)

Babbidge Dam is an earth fill structure with a crest length of 215 feet at elevation 977, and a 36 foot long stop log spillway section. The stop log section consists of four bays each 9 feet wide. The overall length of the dam is 255 feet. Part of the dam structure also contains a gate house with two water supply intake pipes (1.3 and 1.7 foot diameter) and a 2 foot diameter outlet pipe. For the purposes of this report, the outlet pipe will be assumed not opened during flood conditions and hence is neglected from the discharge capacity calculations. Shown on the next page is a sketch of the dam.

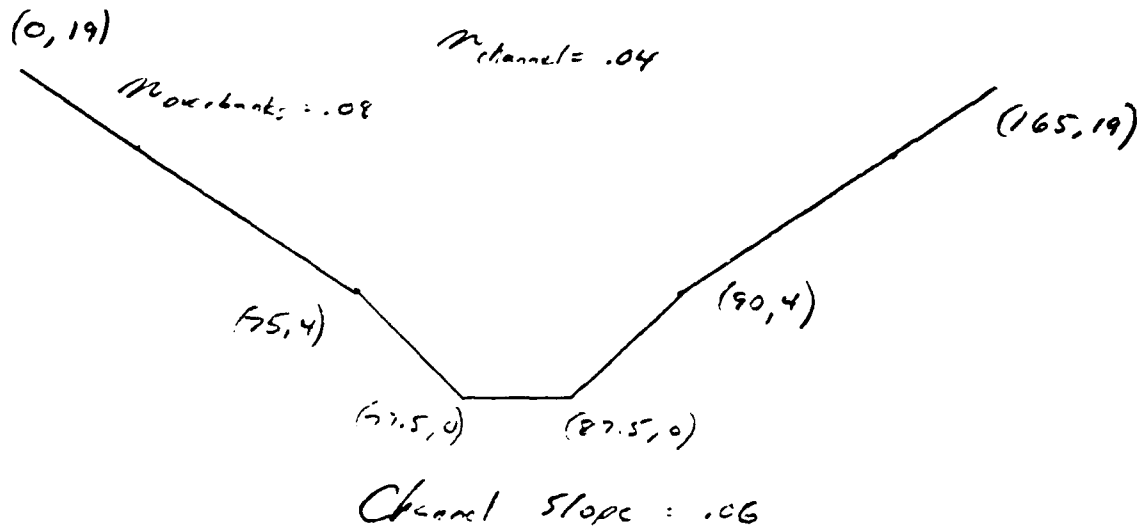
On the next page is shown a typical cross section for Roaring Brook just downstream of the dam.

The stage-normal flow relationship for this reach is given on the next two pages. A pre-failure flow of 485 cfs would cause a stage of about 2.8 feet in the stream below the dam. At the failure flow of 18,485 cfs, however, the stage would rise to a height of 15.1 feet above the streambed, an increase of 12.3 feet.

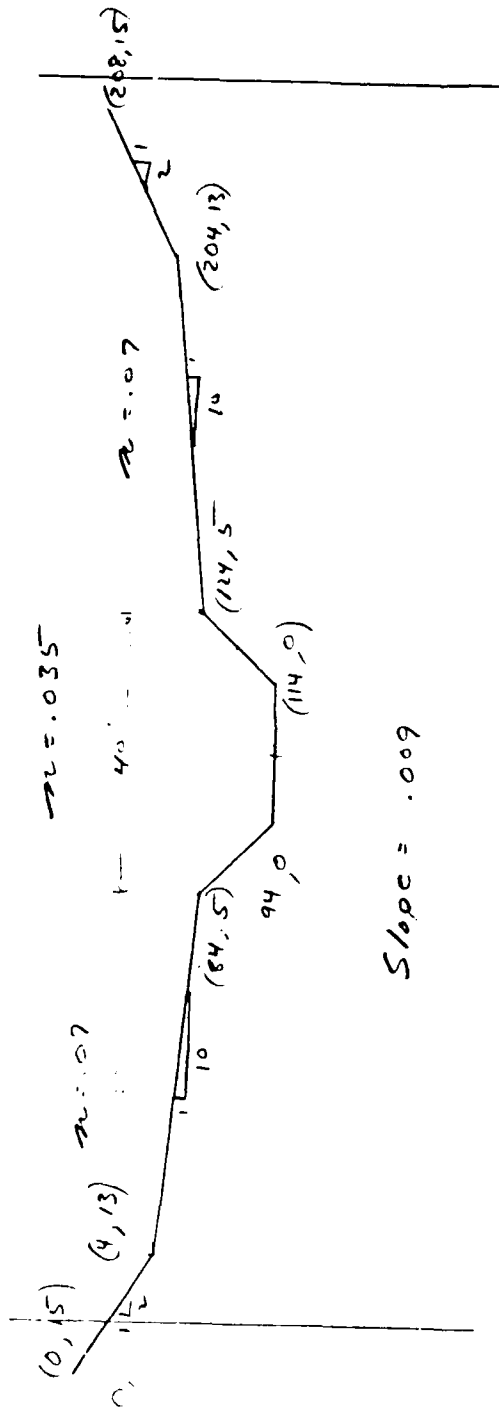
Typical Cross Section for Otter Brook

Immediately downstream of the road, Roaring Brook enters Otter Brook. Along the banks of Otter Brook are three houses which are about 6 feet above the streambed. A typical cross section and rating curve table for Otter Brook are given on the next pages.
